CANADIAN FORCES FLIGHT SAFETY INVESTIGATION REPORT (FSIR)

FINAL REPORT

FILE NUMBER: 1010-12414 (DFS 2-4-2)
DATE OF REPORT: 24 OCTOBER 2000

AIRCRAFT TYPE: CH124A SEA KING
DATE/TIME: 161420 Z JUNE 1999
LOCATION: SHEARWATER, NS
CATEGORY: C CATEGORY ACCIDENT

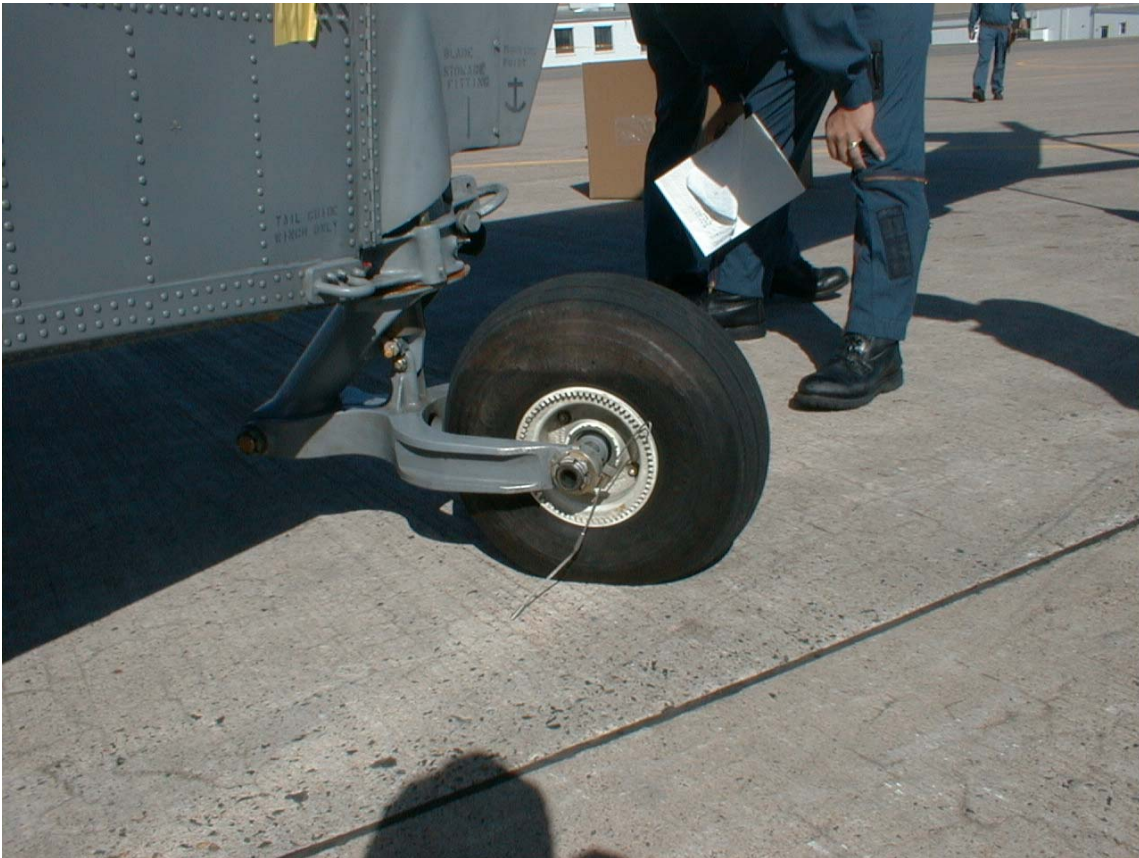
Figure 1 - Tail Strut

The tail wheel strut collapsed and airframe damage was suffered at flight stations 493 and 607. (Figure 1) The number five main rotor blade tip cap contacted the tail rotor drive shaft cover and the number four tail rotor drive shaft. (Figure 2) The tail rotor drive shaft cover was extensively damaged and fragmented (Figure 3); the number 4 tail rotor drive shaft was broken into two pieces and thrown from the aircraft. Two other main rotor blades and one tail rotor blade were damaged by debris (Figure 4). The aircraft sustained C category damage.

- 3.1.14. The tail wheel assembly failed under the forces of ground impact that resulted from the abrupt control inputs of both pilots.
- 3.1.15. The main rotor blade impacted the tail rotor drive shaft because of the abrupt aft cyclic input in concert with a rapid reduction of collective.

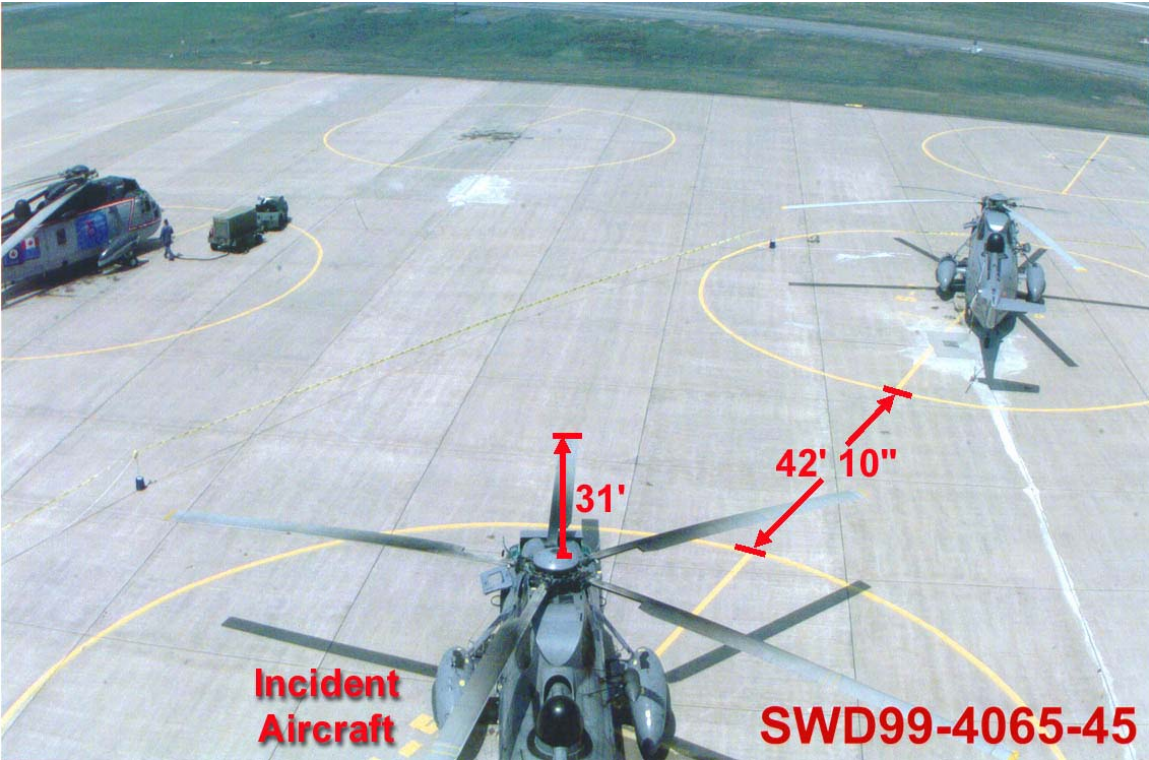
Figure 5: Post-Crash Location of Incident Aircraft

The accident occurred on the inner ramp in front of D Hangar. 406 (HT) Squadron utilises the aircraft parking spots immediately adjacent to "D" hangar. The occurrence aircraft came to rest on spot S-5, having moved approximately 5 feet, but remaining within the circle drawn around the spots, as indicated at Annex A. Each spot has a diameter of approximately 81' 2". Another Sea King was parked on spot S-3, immediately in front of the occurrence aircraft. The distance from S-5 to S-3 is 42' 10". A third Sea King was parked on spot S-4, at the occurrence aircraft's ten o'clock position.

As demonstrated by the photograph at Annex A, there were two helicopters parked in front of the occurrence aircraft when it started to taxi-out. Statements from the occurrence aircrew suggested that there was a certain amount of distraction due to the proximity of other aircraft in the immediate ramp area. Despite the expressed concern, the instructor anticipated no difficulty with the ground taxi manoeuvre, he simply wanted to pay close attention to the ramp traffic, and therefore no consideration was given to the possibility of hover taxiing or waiting for the traffic to clear. Photo-analysis indicated sufficient clearance in all directions to permit safe ground taxi clearance.
